Templeton-Whitney Grazing Allotments, Golden Trout Wilderness

Head Cut and Photo Point Monitoring, 2003 and 2010 (DRAFT)

By: Casey Shannon, Hydrologic Technician

Inyo National Forest, Supervisor's Office

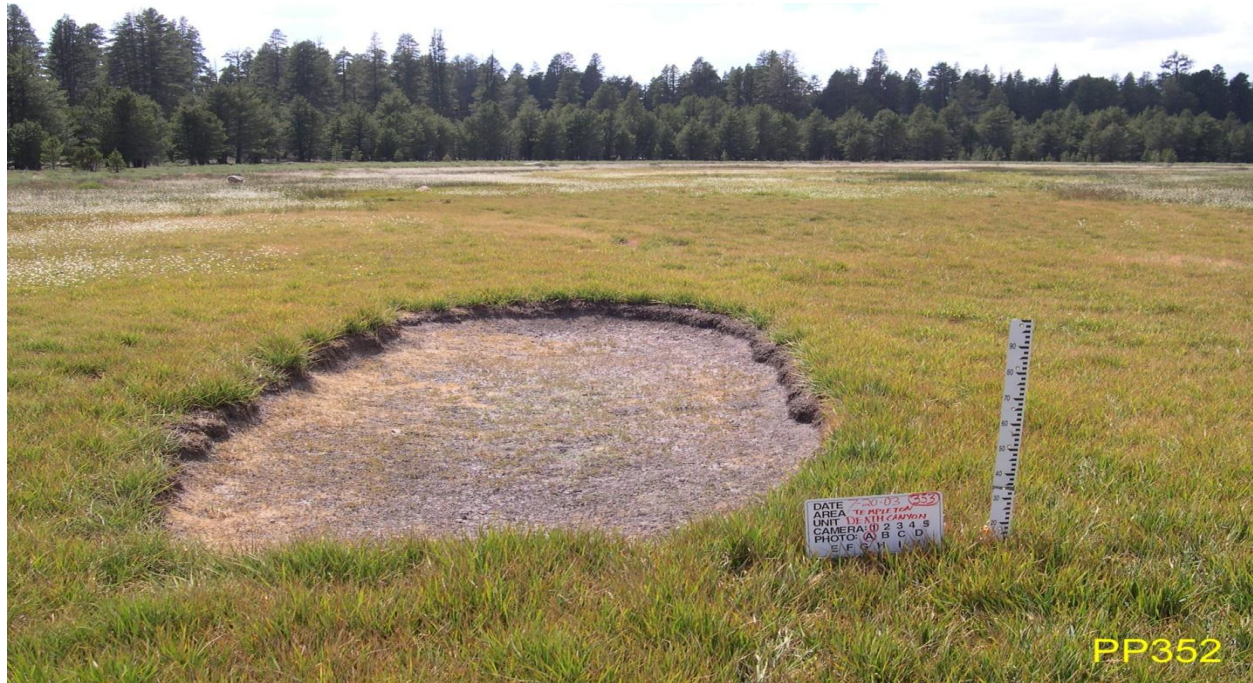
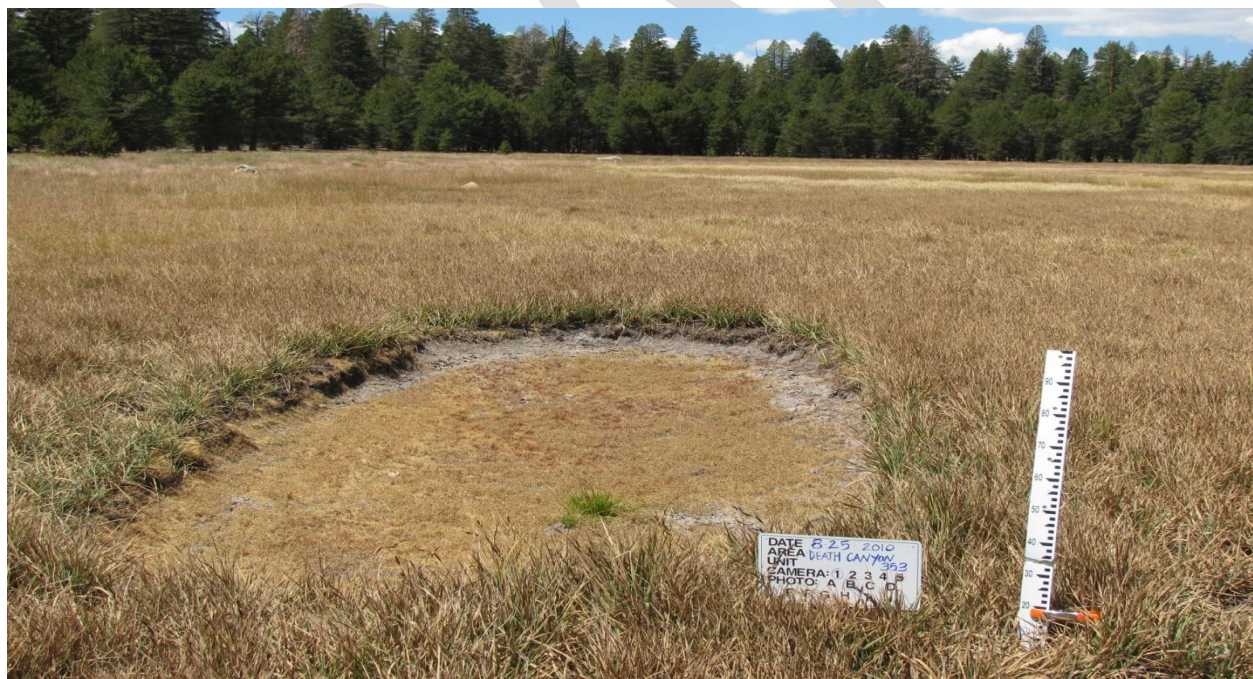
Above photo: Taken July 2003, Photo-point 353 an open “scallop” located in Death Canyon tributary meadow. Cause of sod layer loss is unknown. Overland flow from meadow is captured in the depression with light erosion occurring along edges of the opening. **Below photo:** Same site with photo retaken August 2010, slight improvement as scallop is showing healing, increased vegetation around perimeter and in bottom, overall narrowing of opening, slow progress. Most of the surrounding meadow retains sod layer and is on a low gradient with overland flow regime.

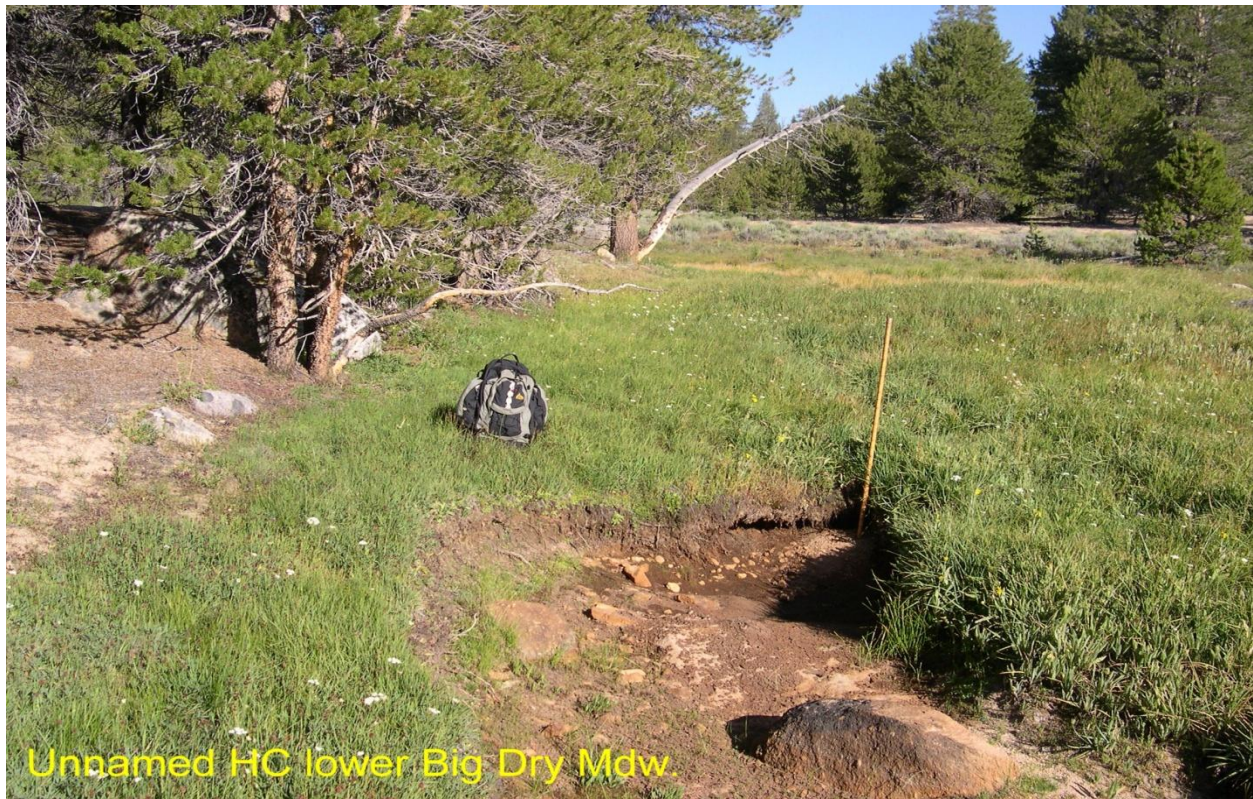
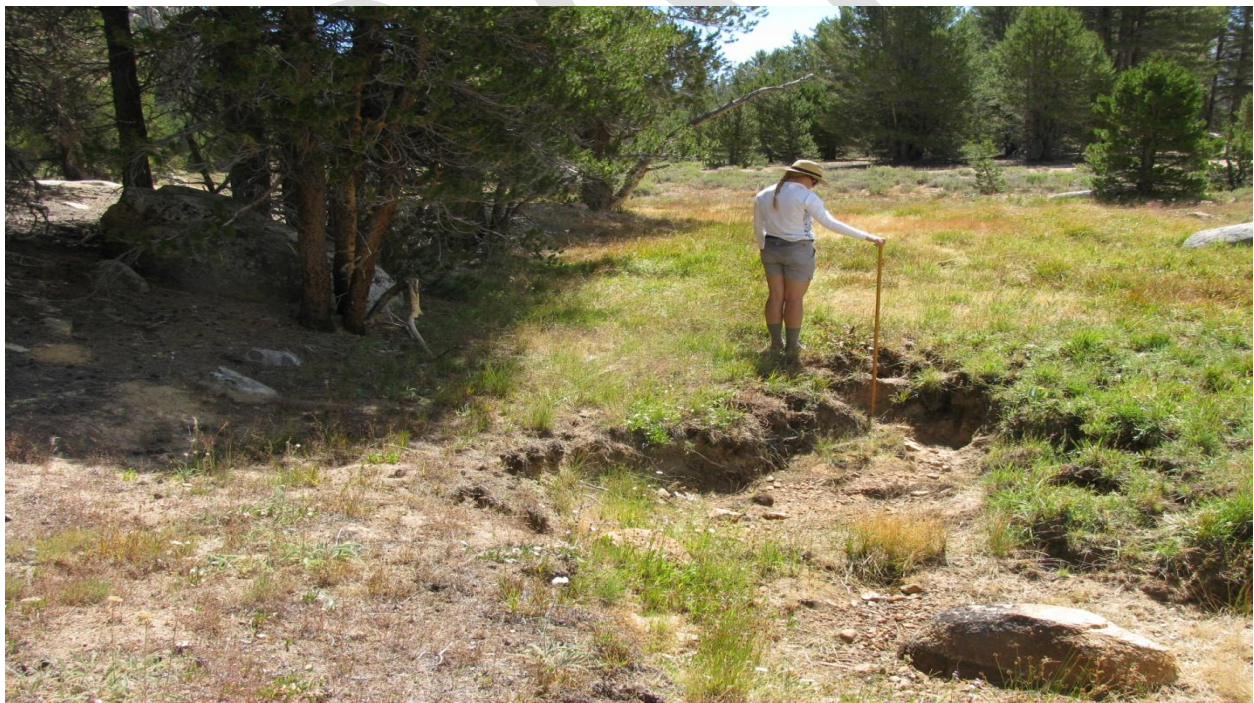
Above photo: Outlet of Big Dry Meadow (Dry Creek) just above Death Canyon confluence, July 2003 of an unnamed active head cut (Site M2). Photo was taken for reference only, no monuments. **Below photo:** Same site with photo retaken August 2010. Head cut has migrated approximately 3.5 meters and slightly widened. Large rock and boulder substrate checks erosion rates. Overland flow does not fully concentrate at head cut and spreads into nearby lateral channels. Disturbance at head cut could increase erosion rates.

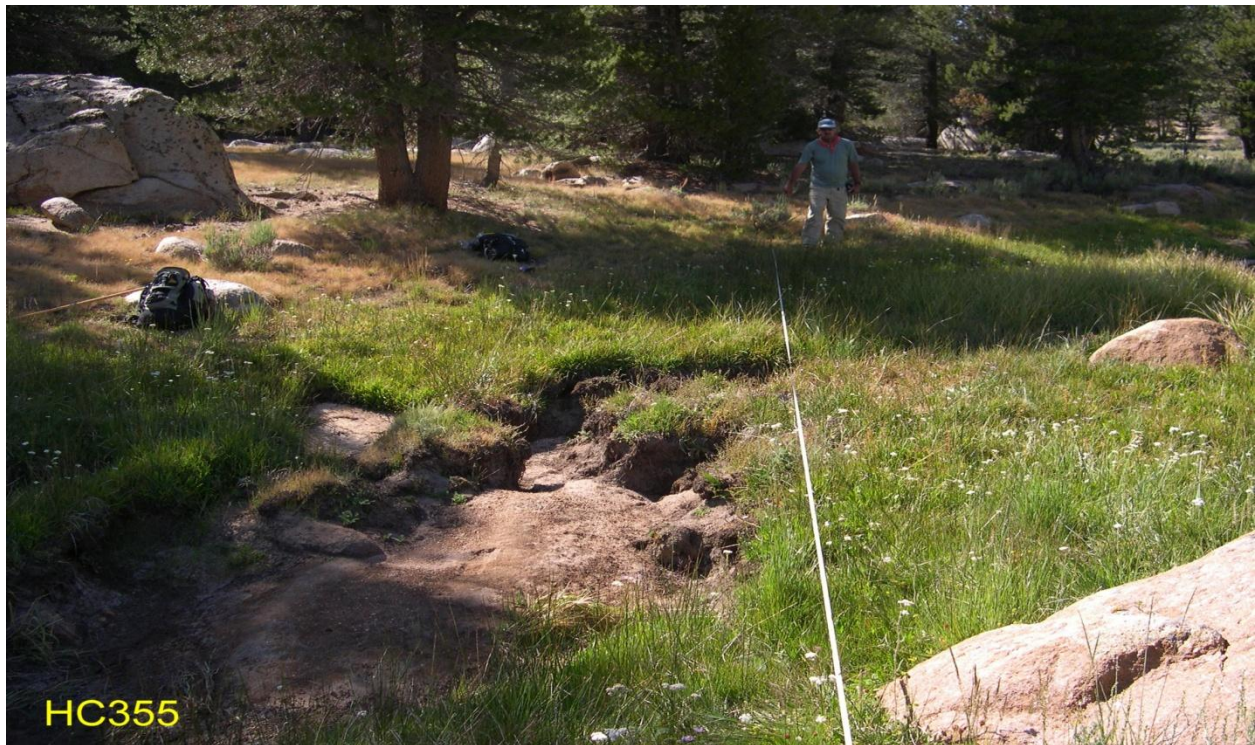
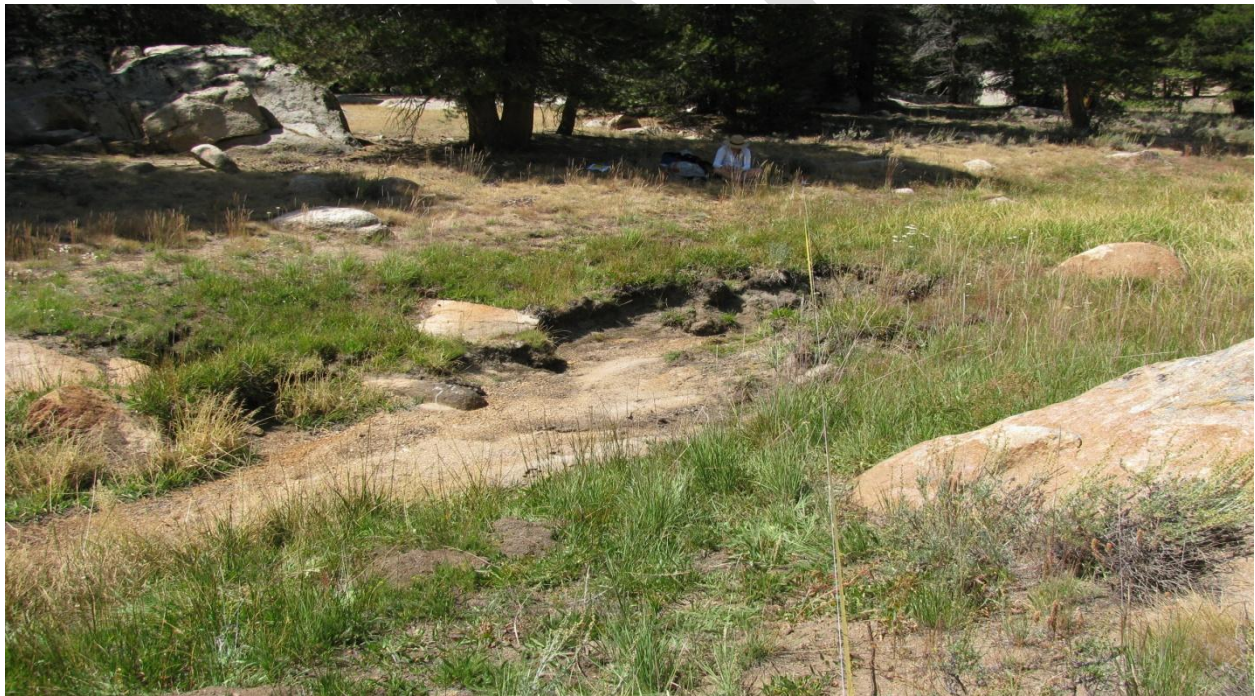
Above photo: Head cut 355 (HC 355) Death Canyon Tributary, July 2003. HC 355 is a large and open HC with gully formation below. Photo was also taken of this HC in 1997. **Below photo:** Repeat photo was taken August 2010. Additional erosion has occurred since 2003 HC has migrated 1.83 meters which is slow migration but HC has deepened and widened and is active. HC has incised below root zone and is undercutting banks. This condition could lead to increased migration if a large hydrologic event occurs. There are two successfully treated HC's just above HC 355 that could be threatened with migration. This HC is a candidate for stabilization treatment as a healthy sod layer exists to work with.

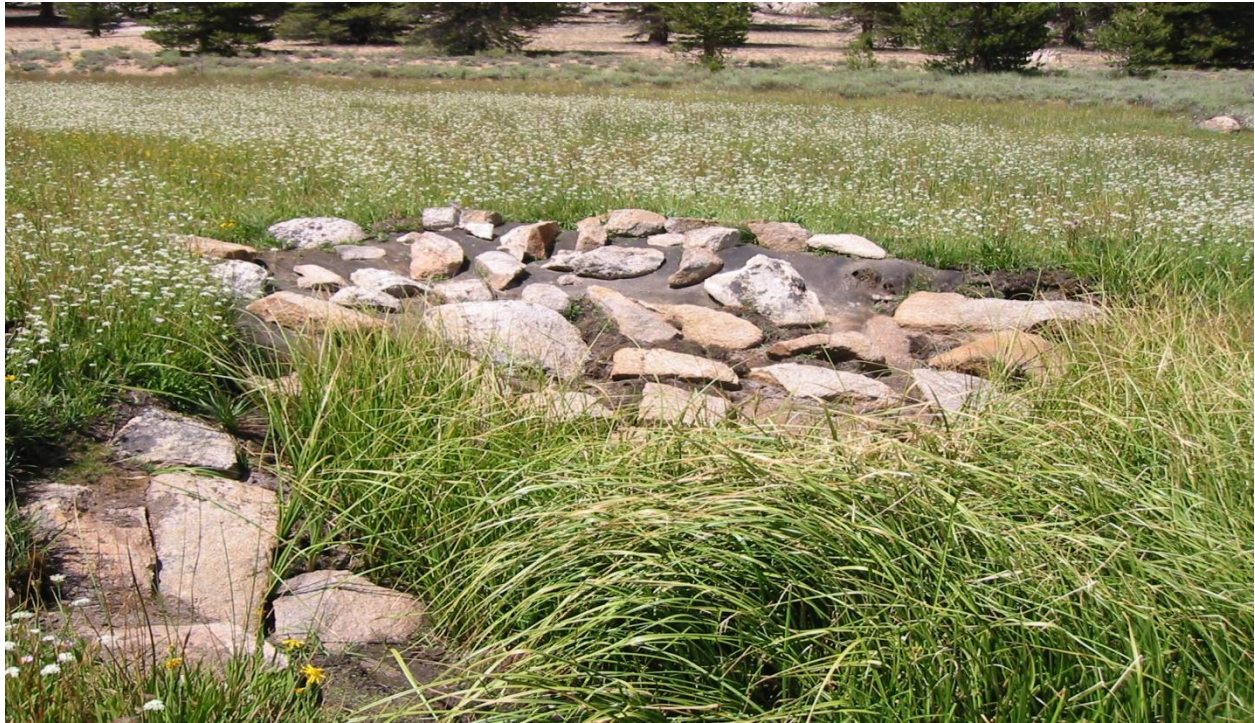
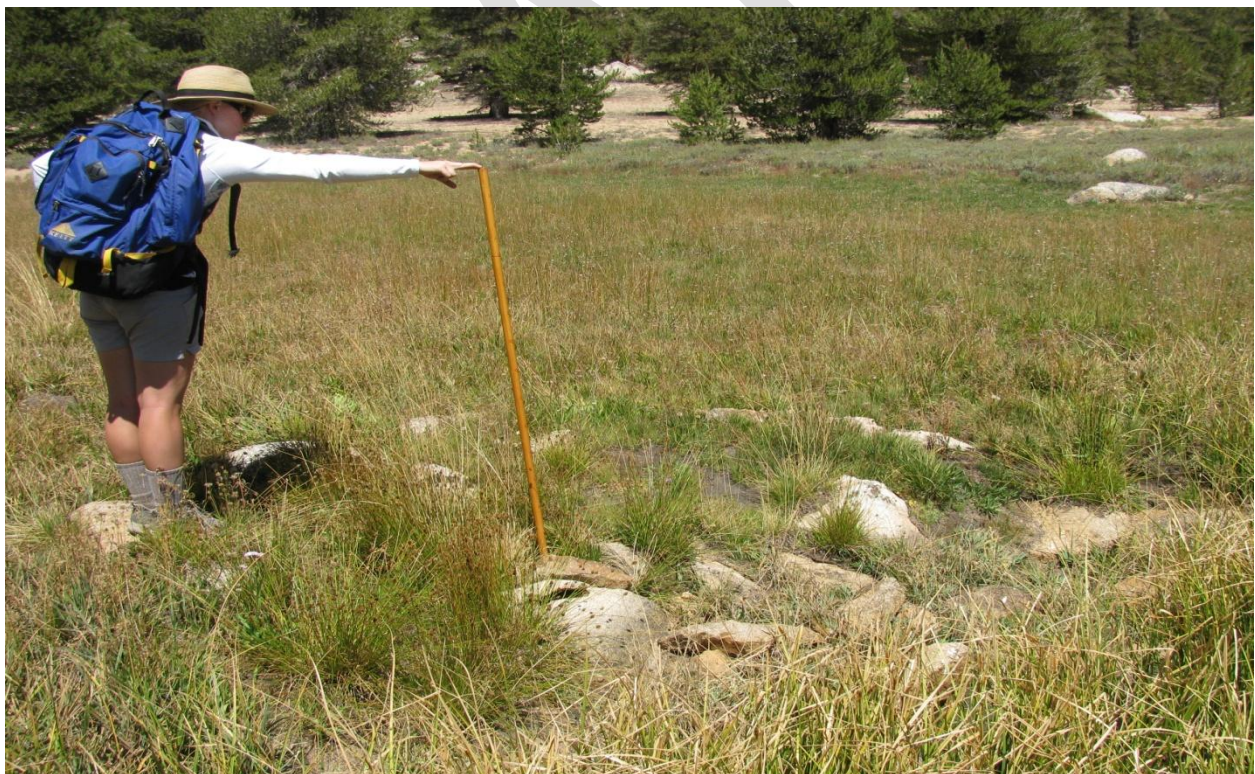
Above photo: Treated Head Cut 352 (THC 352), Death Canyon Tributary July, 2003. THC 352 was initially treated in 2002 by the Inyo watershed crew. Head cut was sloped, covered with inka-mat filter cloth and armored with large rock. Open space between the armor was set up to allow infiltration and solar exposure and a few sod plugs were placed. **Below photo:** THC 352 Death Canyon Tributary with photo re taken August 2010. Treatment has fully stabilized the site. Overall floodplain level at site has elevated with vegetation filling in over the structure providing strength. Gully below structure has filled in and elevated, treatment has met prescription objectives.

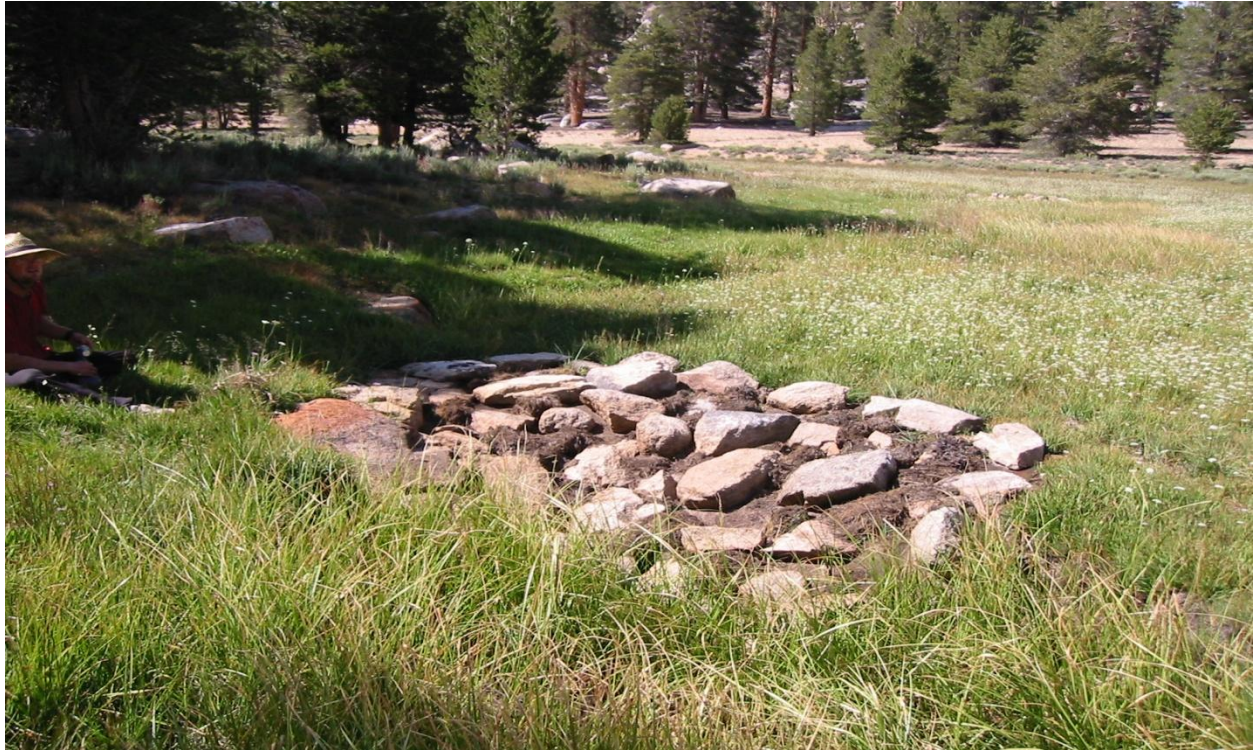
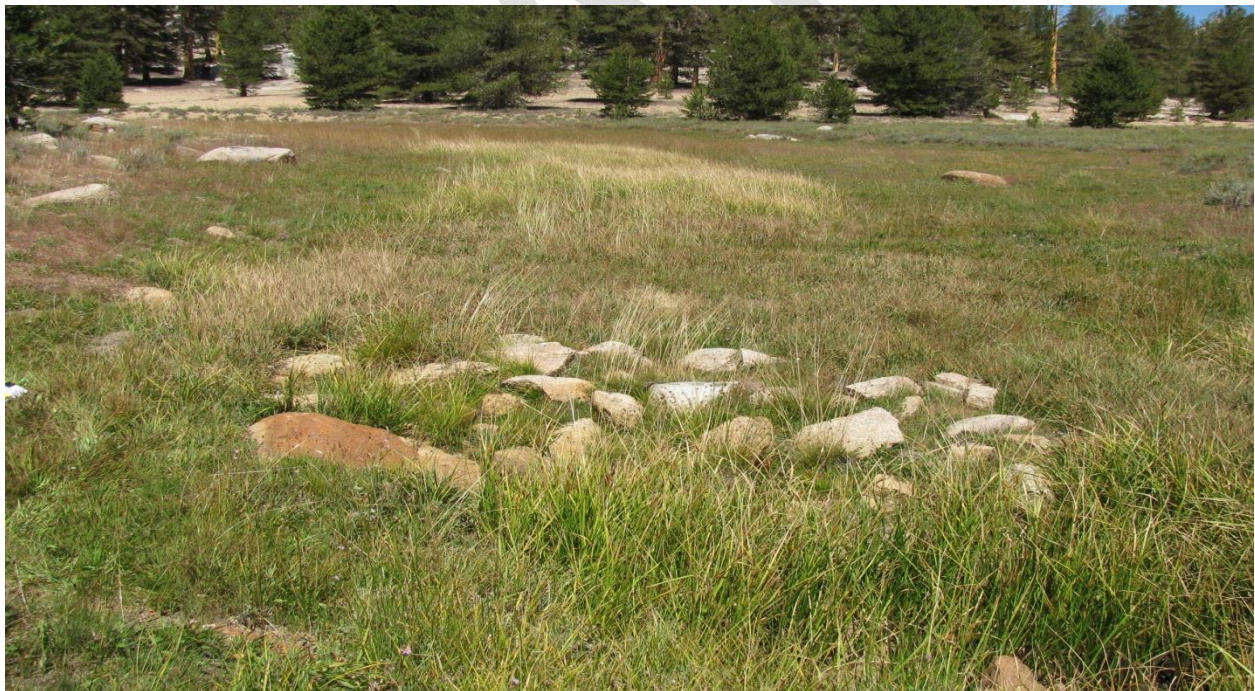
Above photo: Treated Head Cut 354 (THC 354) Death Canyon Tributary, July 2003 one year after initial treatment (2002). THC 352 is approximately 35 meters upstream. Once an open faced, deep, scalloped HC, the HC was sloped and inka-mat filter cloth was used as an underlayment with rock armor structure on surface. **Below photo:** THC 354 Death Canyon Tributary with photo re taken August 2010. Floodplain vegetation has elevated and is filling around structure providing an anchor and resistance to scour from peak flows. Prescription objectives have been met. Favorable low gradient floodplain with overland flow and with deep organic layer and well developed, rooted vegetation is a key factor in treatment success.

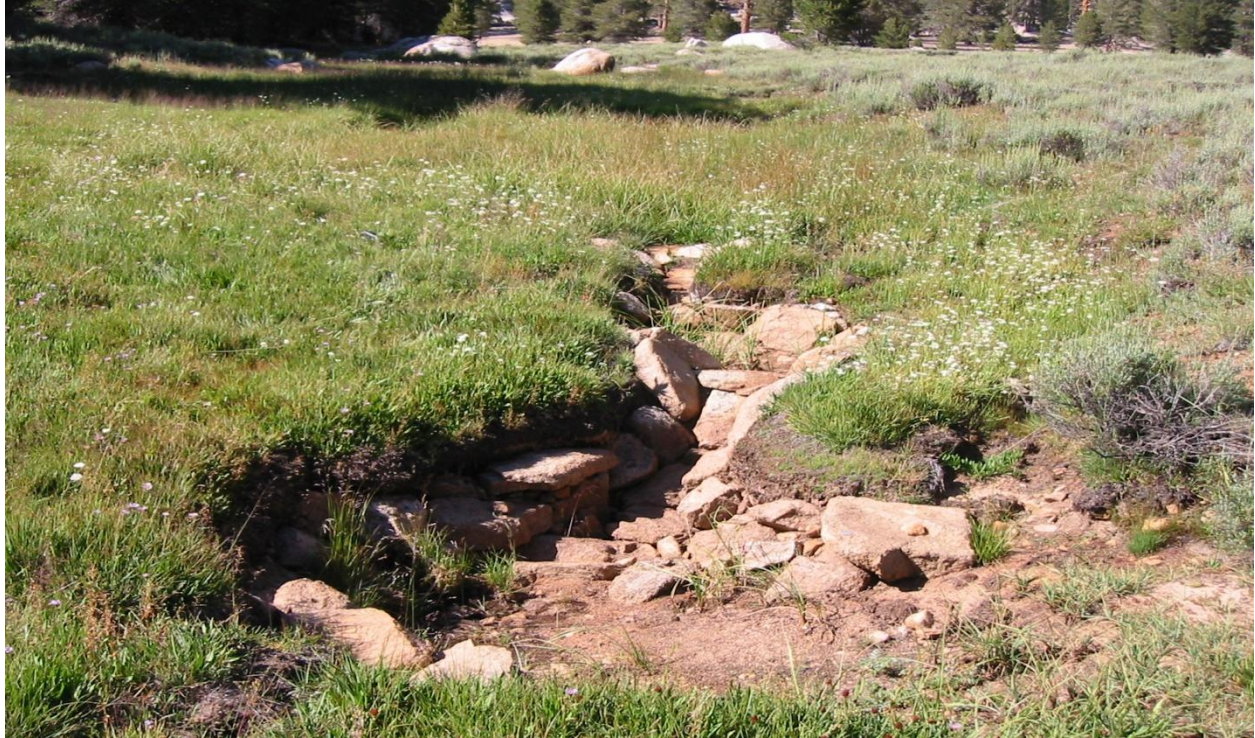
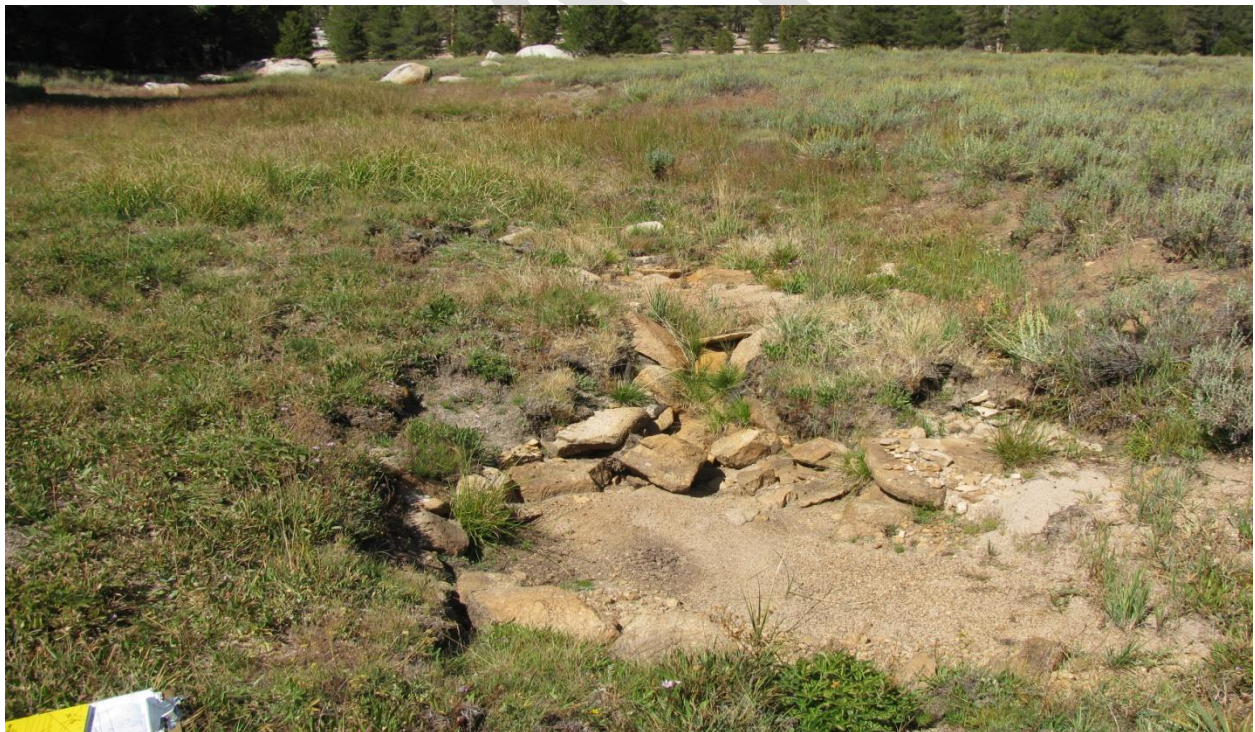
Above photo: Treated Head Cut 251, (THC 251) Death Canyon Tributary July 2003. A two tier rock chute structure, no filter cloth underlayment was used. **Below photo:** THC 251 Death Canyon Tributary with photo re taken August 2010. Structure has some light amounts of filling of vegetation on banks that has occurred, flow has started to migrate out of the structure to the right side facing upstream and a small new head cut has formed at the top of the upper tier. Not using filter cloth may have contributed the structure problems. THC is in need of repair to re-stabilize.

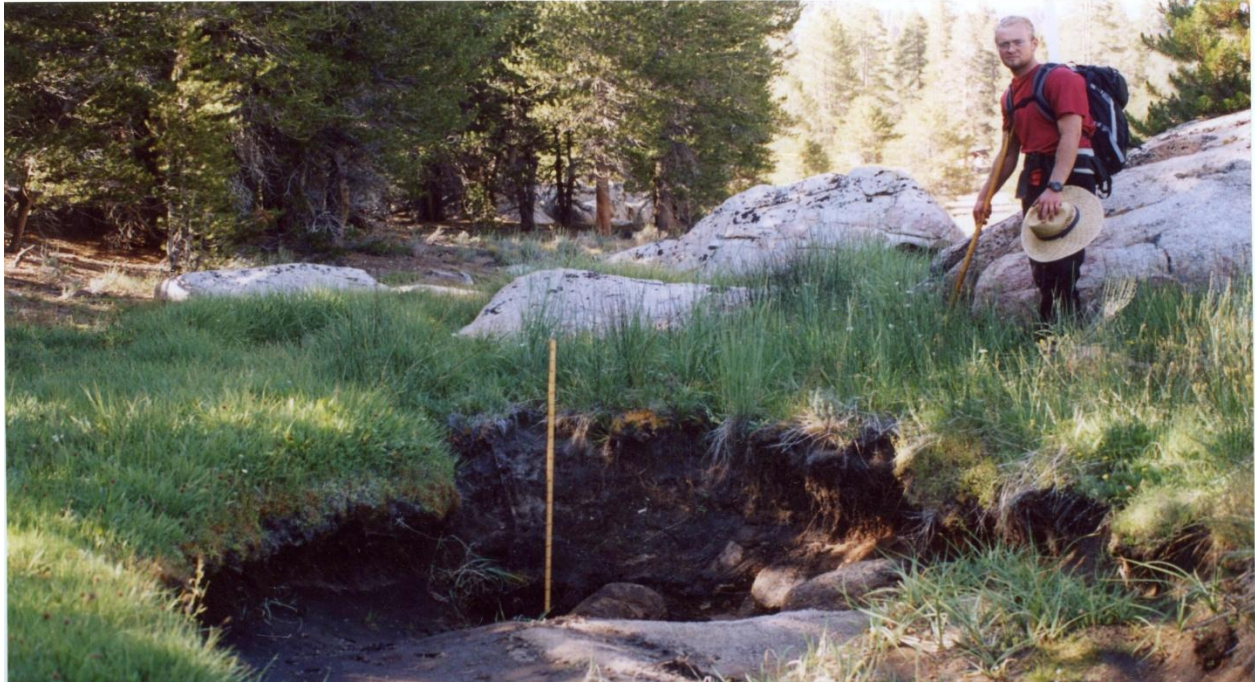
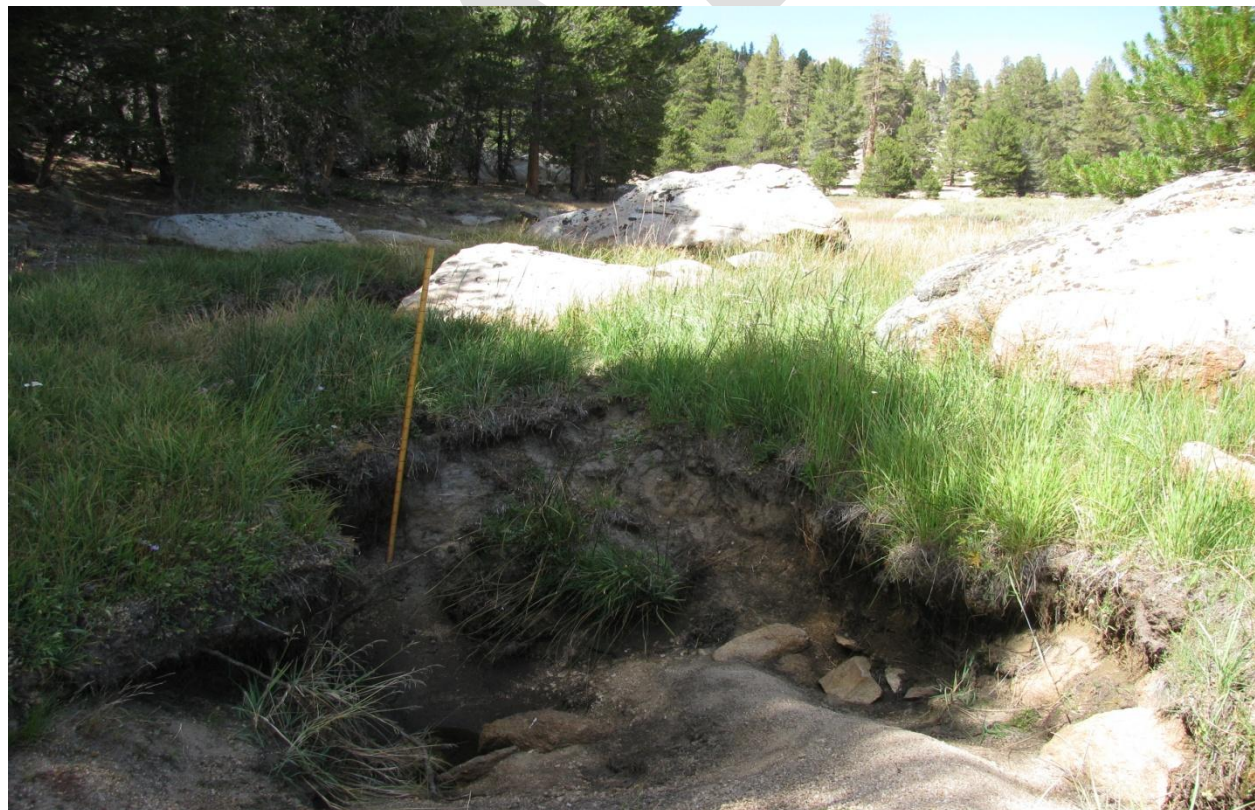
Above photo: Monitoring Site 2 (M2), an unnamed head cut, Death Canyon Tributary, July 2003. Photo was taken for observation purposes, monuments and other HC data was not set up at this site. Same site photo was taken during 1997 Amendment 6 monitoring. **Below photo:** M2 Death Canyon Tributary with photo re taken August 2010. Head cut has not migrated much, approximately 1 meter and has widened in area and soil erosion is occurring. Large boulders in channel will likely restrict head cut migration in the future, site is unstable.

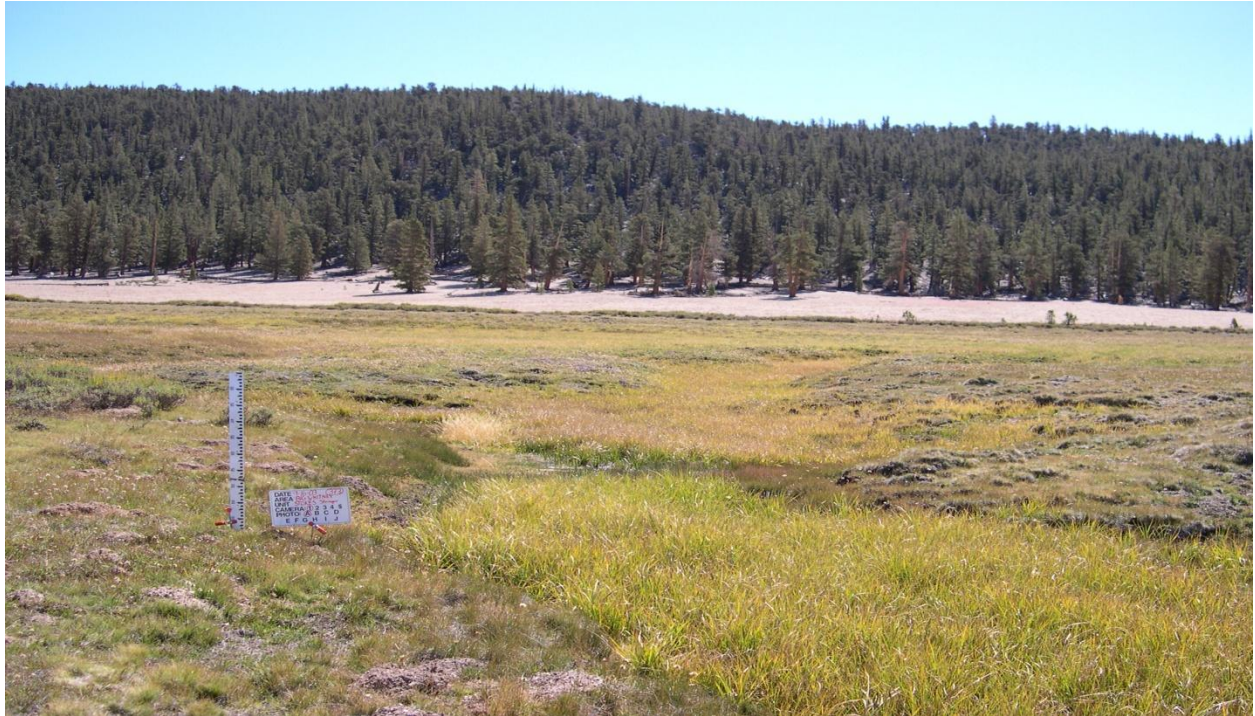
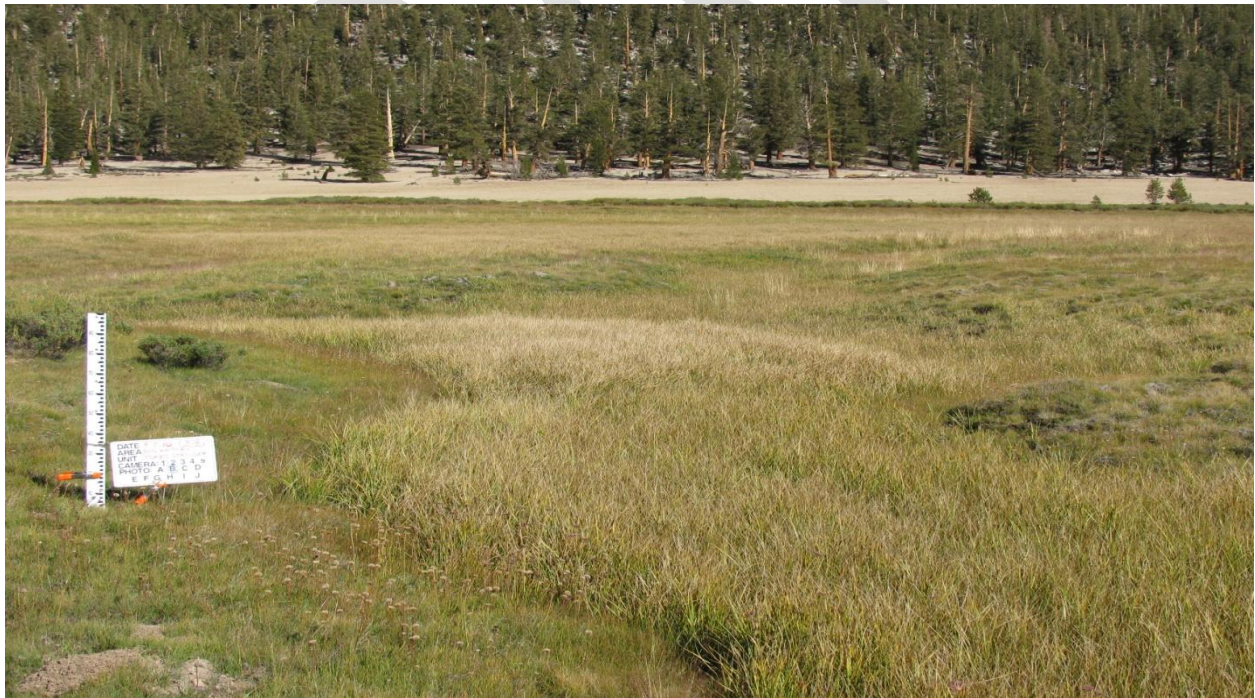
Above photo: Photo point 373-1A (PP 373 1A) Stokes Stringer section 1, September 2003. The hummocks on the higher knolls are obvious, vegetation cover is thin. **Below photo:** PP 373 1A photo retaken September 2010. Hummocks have started to lose definition and have more vegetative cover. Floodplain in channel has started to aggrade and sedge is expanding upwards to upper slopes. Overall, vegetation and soil stability has increased. Hummocks are still vulnerable to disturbance due to wet soil conditions.

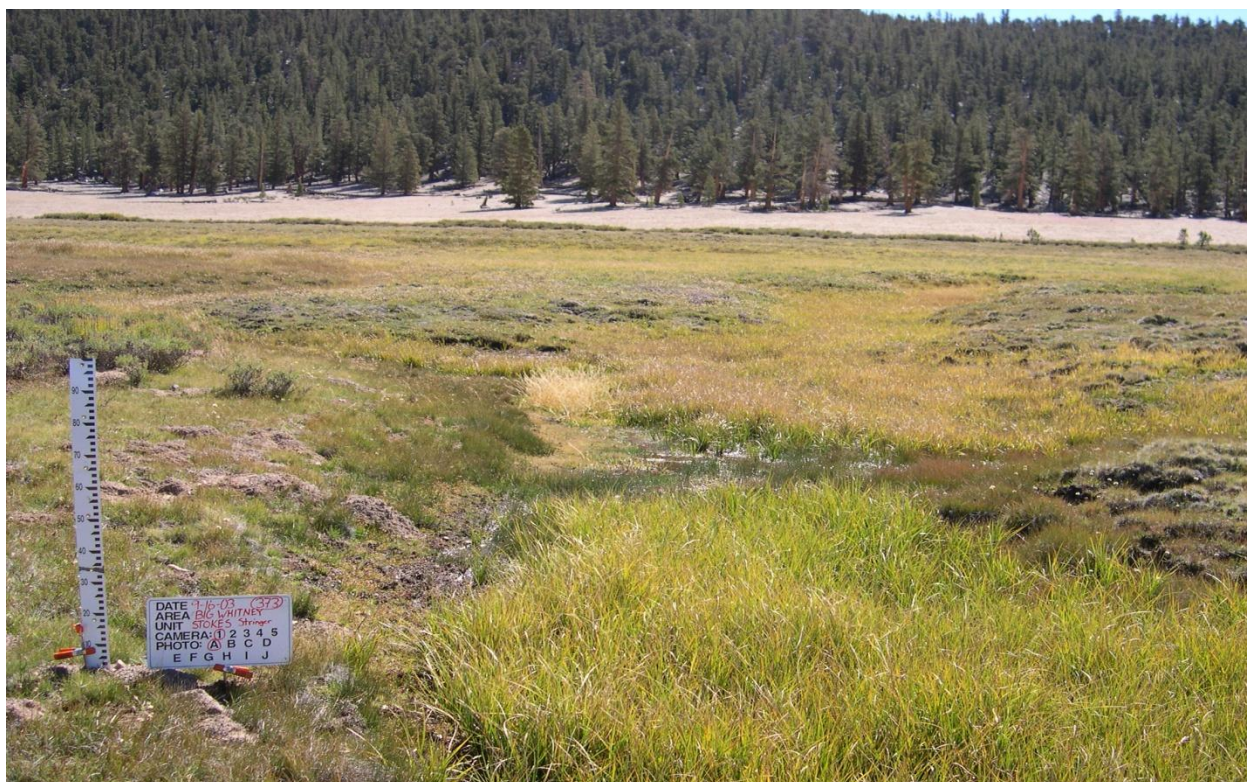
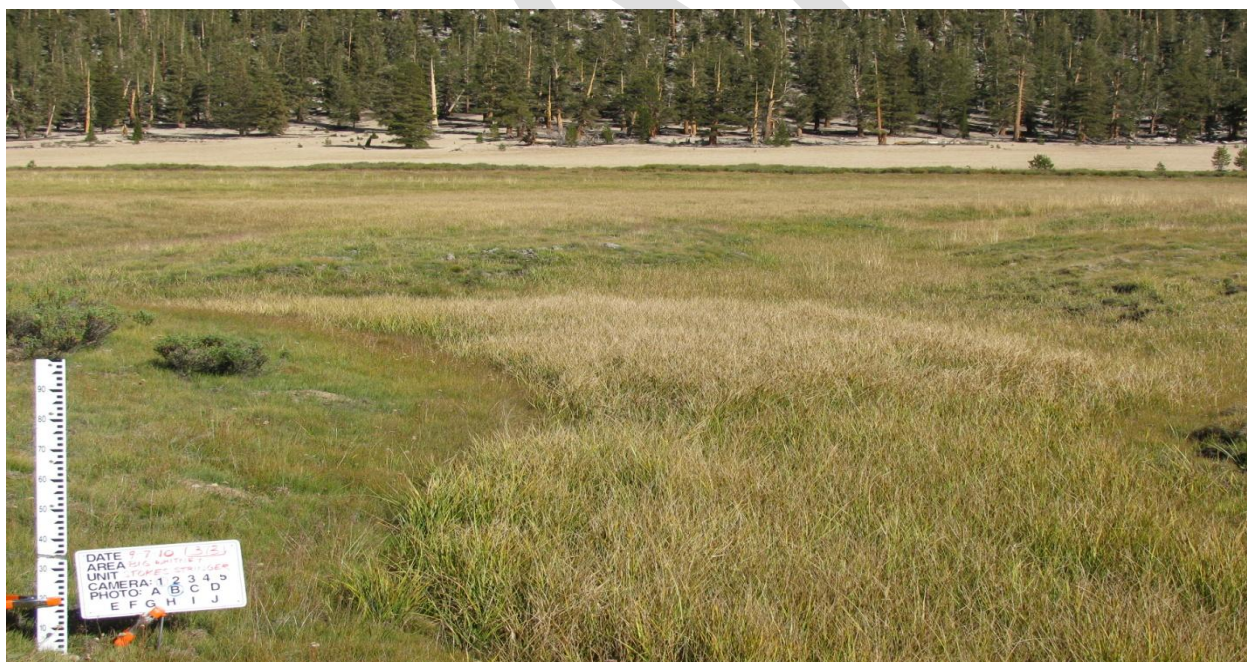
Above photo: Photo point 373 2A (PP 373 2A) Stokes Stringer section 1, September 2003. This is a closer view of PP 373 1A and area immediate to drainage and floodplain. **Below photo:** PP 373 2A photo retaken September 2010. Riparian vegetation (mostly sedge) has increased cover and density in channel and adjacent slopes are filling in with vegetative cover (over hummock areas). Water table has elevated since 2003 to a moderate degree. Rodent activity has slowed. Old incised drainage is aggrading towards terraces. Site has wet, vulnerable soil.

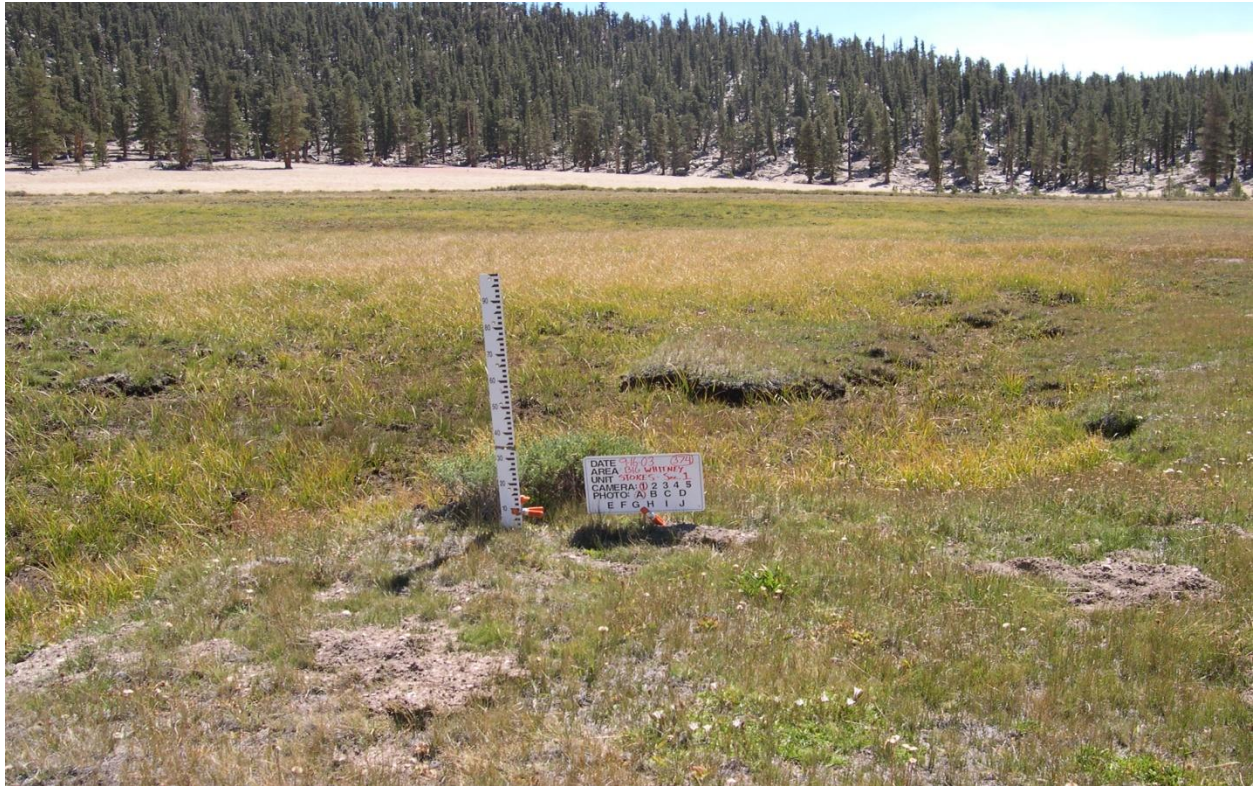
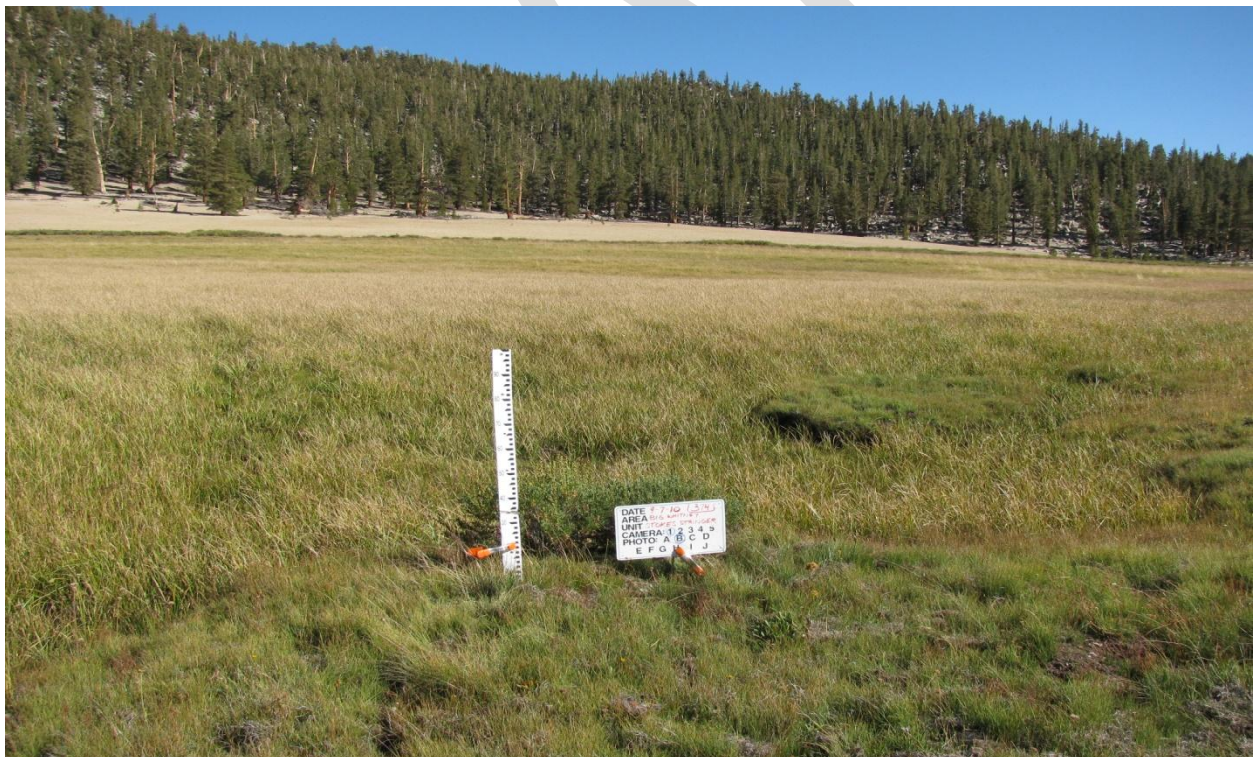
Above photo: Photo point 374 Stokes Stringer section 1, September 2003. Photo shows partial bare ground and eroded hummocks with diminished vegetation. **Below photo:** Retake of photo September, 2010. Hummock areas have started to heal and vegetative cover has increased significantly over the area adding to soil stability. Soils are very moist to wet within the drainages.

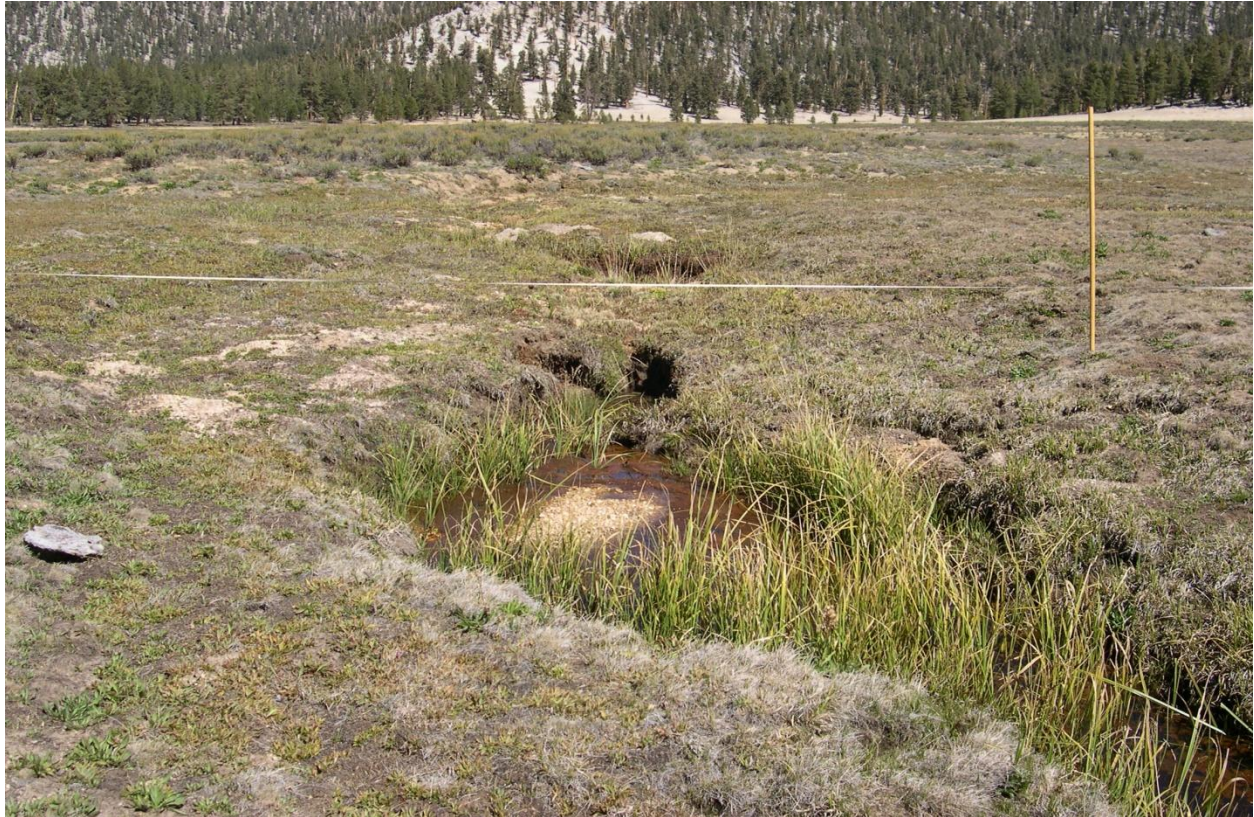
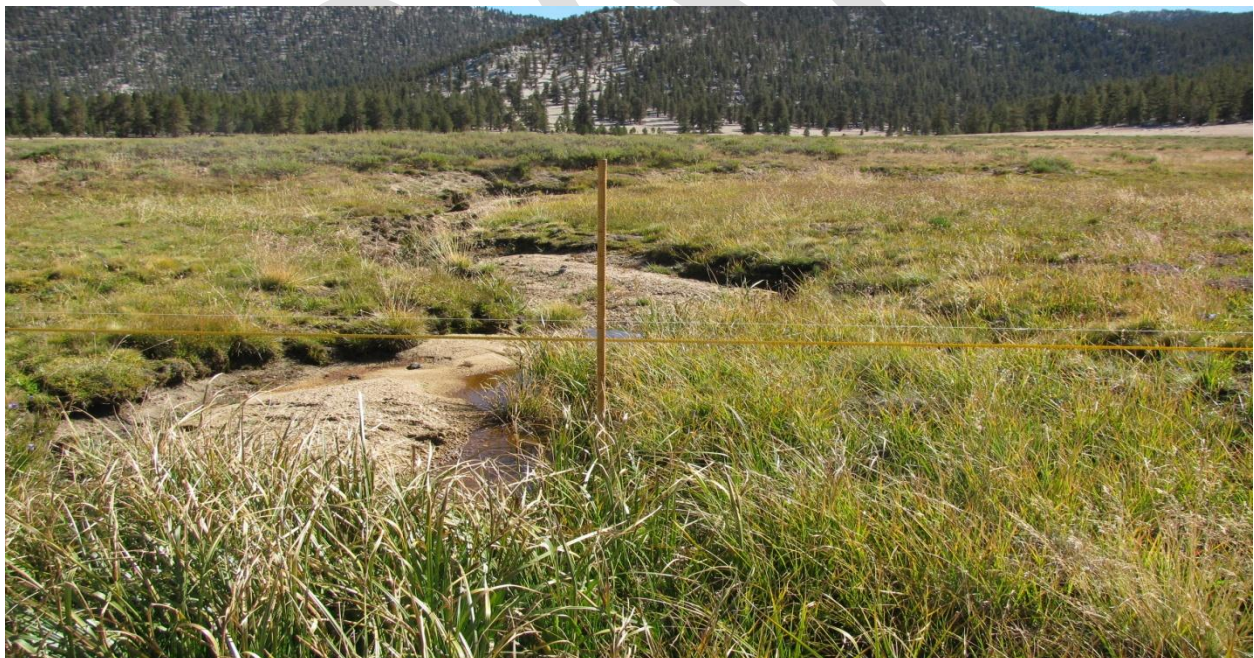
Above photo: Head cut 375 (HC 375) Stokes Stringer Section 1, September 2003. Tape transect is where top of head cut is located. Thin organic horizon exists at this site (0.01m) and alluvial. **Below photo:** HC 375 Stokes Stringer section 1 retake of photo September 2010 showing 2003 transect (at meter rod). Head cut has advanced 46 meters since 2003. Thin organic layer and deep, underlying loose alluvial soils are conducive to head cut migration at this site, the head cut will continue to rapidly move upstream with each runoff event. Site is sensitive to disturbance.
